Manhole Inspection Summary

Manhole # S47CC_033MH

Insp Date: **2/7/08 11:15 AM**

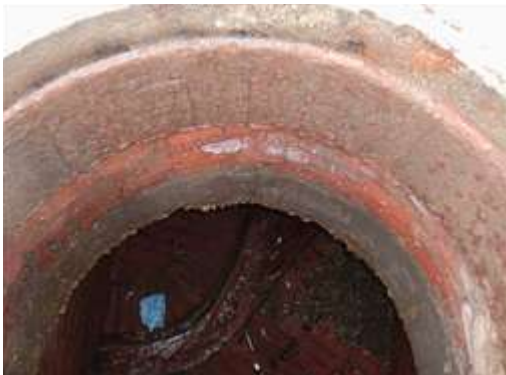
Defect 2

Frame Offset: **1** (in.) Condition: ☐ Sound ☐ Cracked ☒ **Leaks**

Frame Leaks

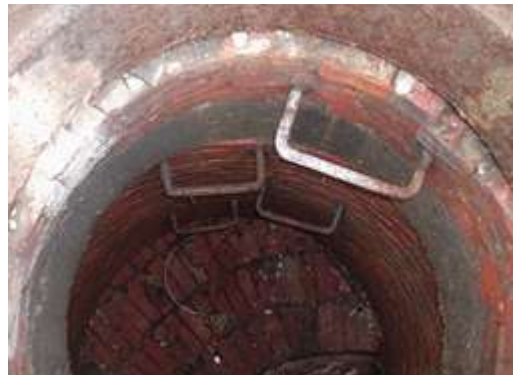
Defect 1

Condition: ☐ Sound ☒ **Cracked** ☐ Root Intrusion ☒ **Loose Brick** ☒ **Deteriorated**

Infiltration: ☐ None ☒ **Joint** ☐ Cracks ☐ Mortar ☐ Roots ☒ **Wall**

Loose Bricks

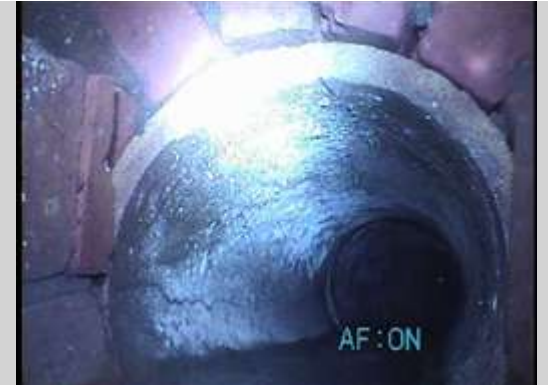
12 O'Clock Outflow

8 in. Circular Gravity Sewer
Pipe Out @ 12 O'Clock

Pipe Height: **8.4** (in.) Rod and Bar (Angled)
Pipe Material: **Clay** ☐ Pipe Lined
Invert Depth: **8.00** (ft.) Flow Characteristics: **Fast**
Deposits: ☒ None ☐ Mud ☐ Sludge ☐ Debris ☐ Grease
Silt Depth: (in.) Deposits Extent:
Infiltration: **None** Pipe Seal Cond: **Sound**

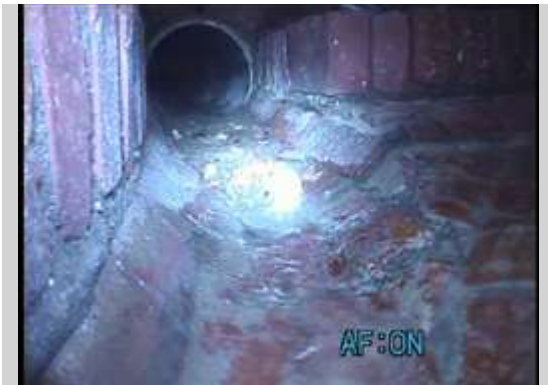
3 O'Clock Inflow

8 in. Circular Gravity Sewer
Pipe In @ 3 O'Clock

Pipe Height: **8.4** (in.) Rod and Bar (Angled)
Pipe Material: **Clay** ☐ Pipe Lined
Invert Depth: **8.30** (ft.) Flow Characteristics: **Fast**
Deposits: ☒ None ☐ Mud ☐ Sludge ☐ Debris ☐ Grease
Silt Depth: (in.) Deposits Extent:
Infiltration: **None** Pipe Seal Cond: **Sound**

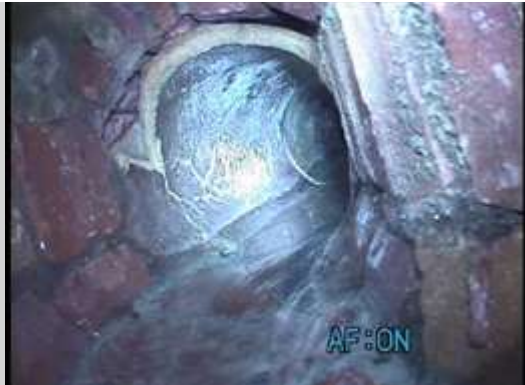
6 O'Clock Inflow

8 in. Circular Gravity Sewer
Pipe In @ 6 O'Clock

Infiltration: **None** Pipe Seal Cond: **Sound**
